## Polyvision Window - Advised Rework Instruction

### Overall Repair Issue :

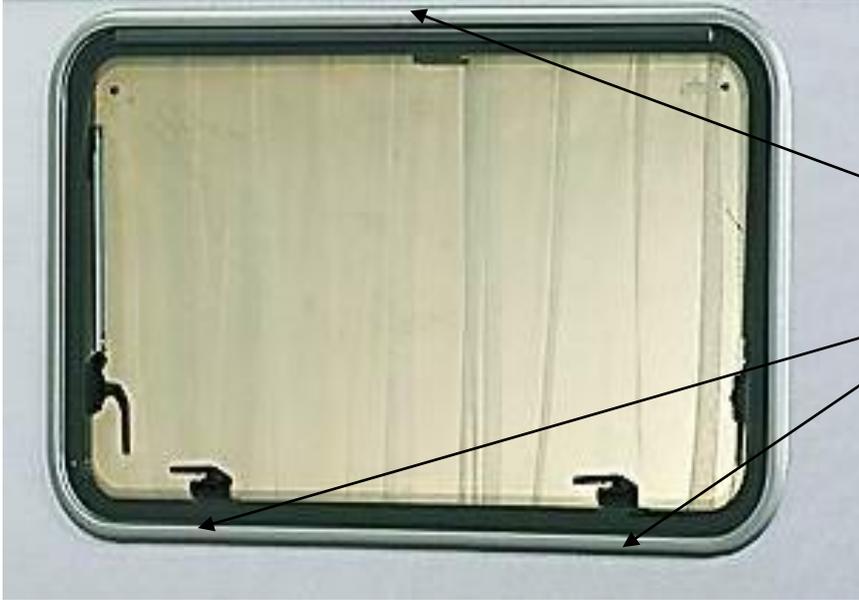
Area 1 - Frame joint - needs extra sealant within the aluminium profile

Area 2 - Bottom of frame - needs drain holes installing
