Autotrail Cheyenne 6969 N<sup>o</sup>. 10083, 2005.

Richard Casselle.

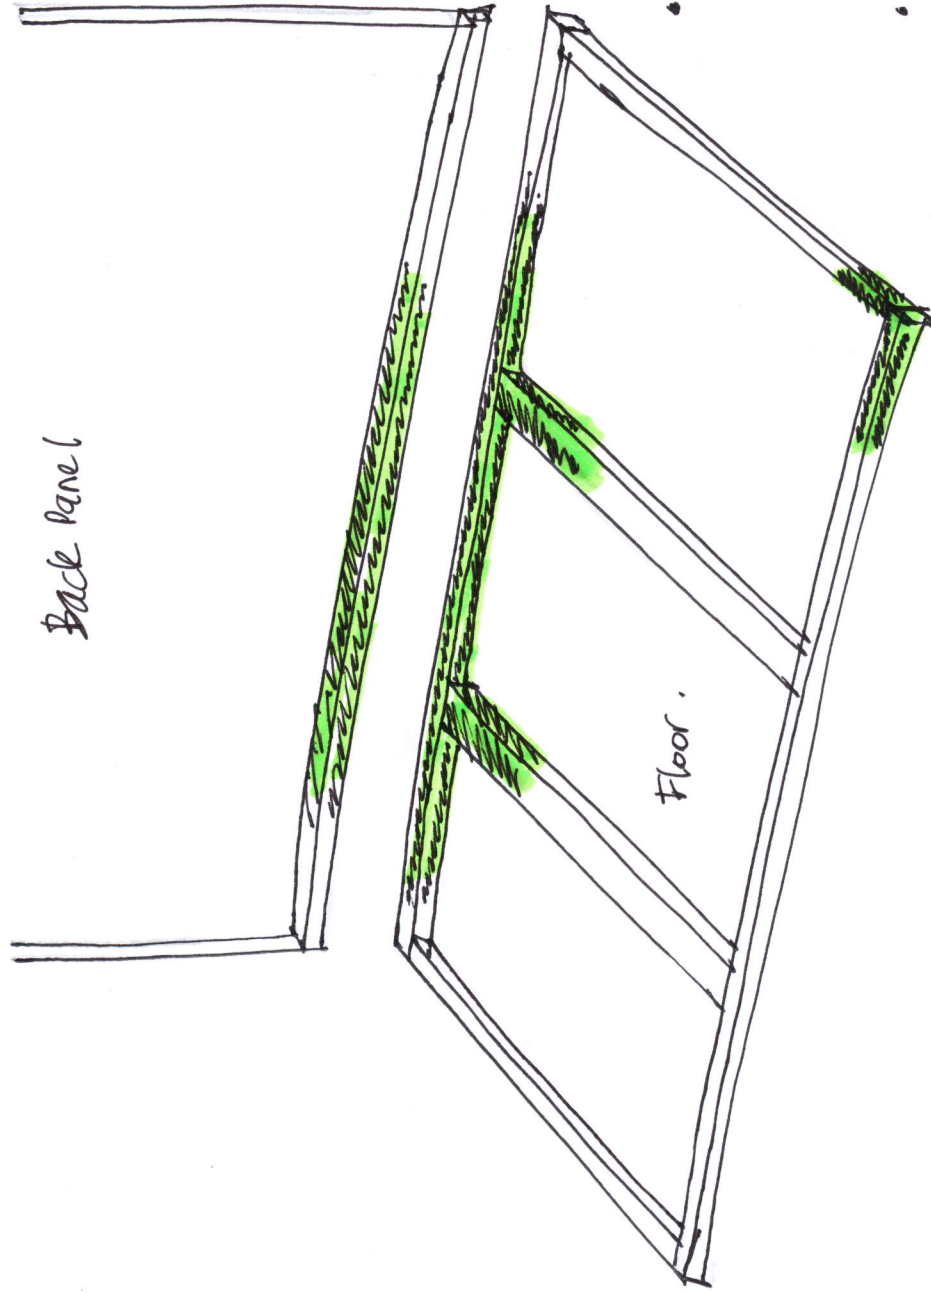
- Bottom timber edge to back panel rotted.

- Bottom part of ply fascia rotted.

- Rearmost timber edge and longitudinal timber braces rotted.

- Front NS corner of floor panel rotted

- Ply surface rotted.
